Engineer's Foundation Evaluation

123 Sample Address, Your City, TX, 12345

0.0 - Background and Purpose

On 12/31/2024 a foundation evaluation was performed at the property located at address 123 Sample Address, Your City, TX, 12345, which consists of a 2042 square-foot single family attached structure built in 2005 with a slab on grade foundation.

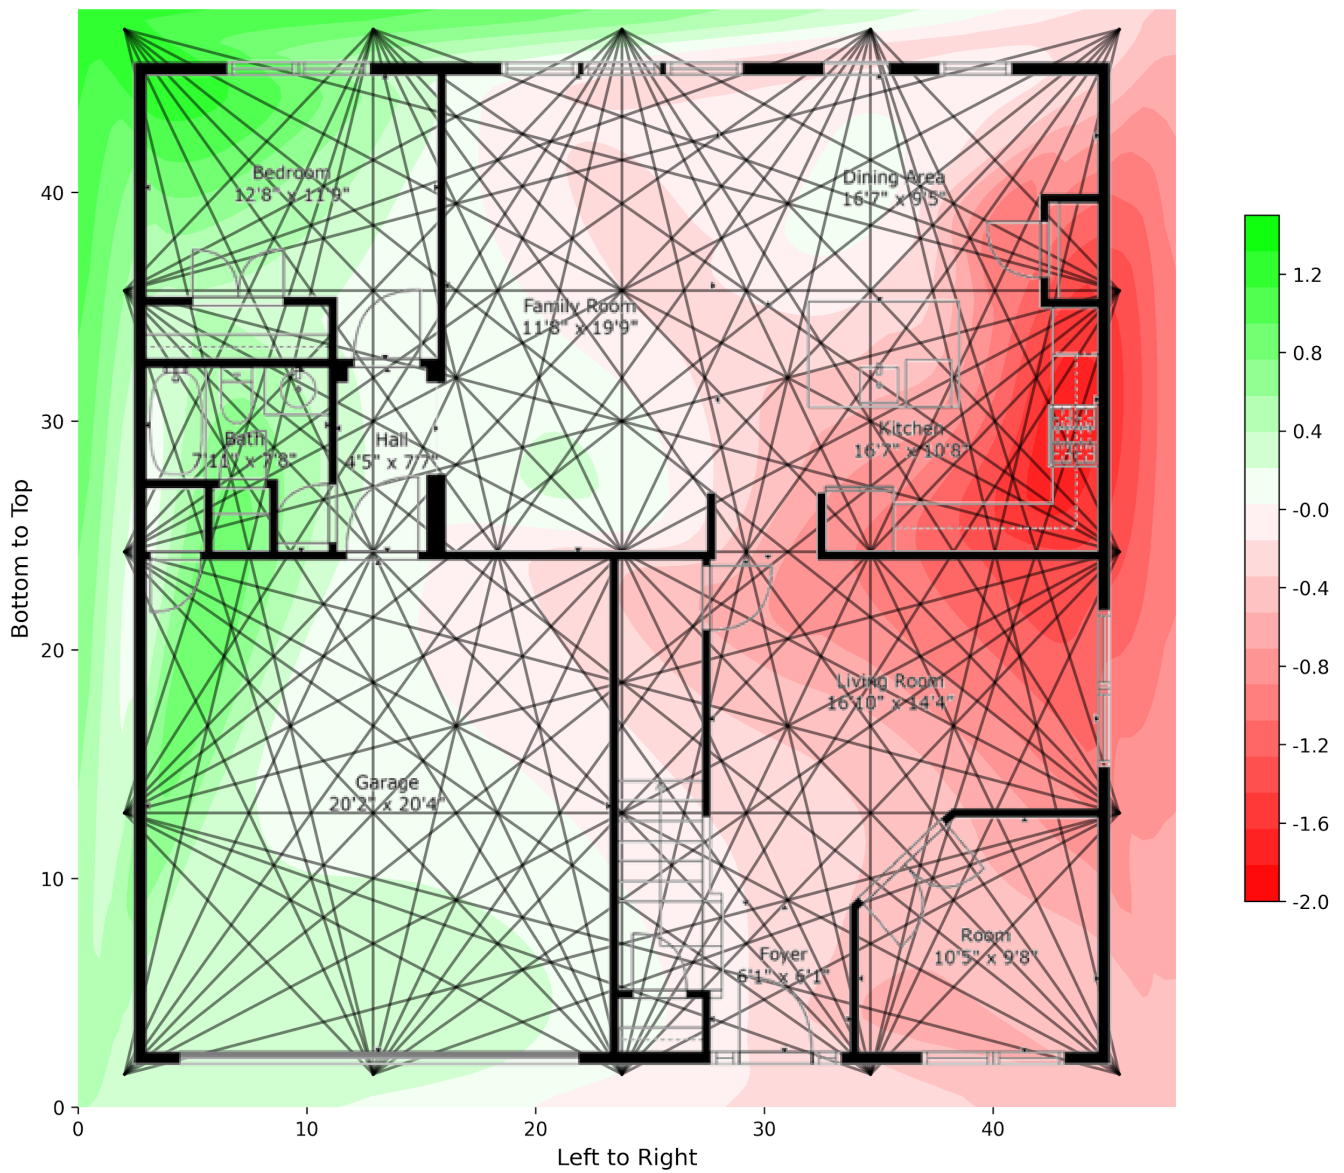
All Profiles Graphic (Figure C)

Below is a graphic that shows the locations of deflection and tilt profiles that were calculated. The total profiles calculated was 79 with a total usable profiles (above the effective length threshold) of 76.

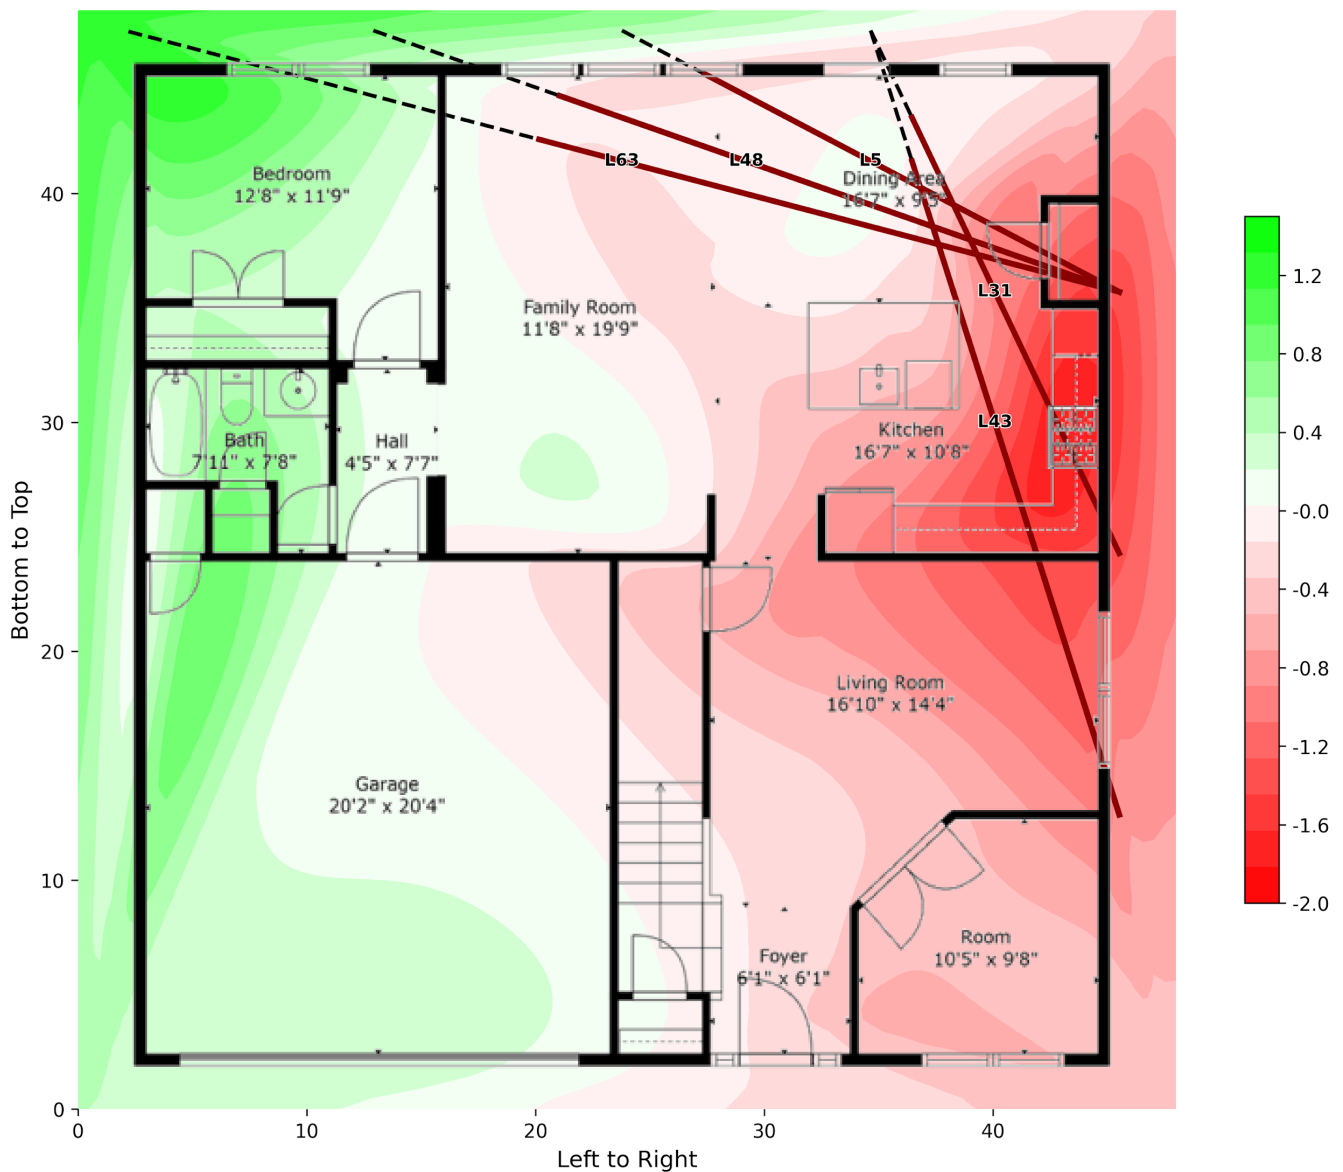
Deflection Failures Graphic (Figure D)

The above Figure D shows deflection failures along the foundation. Deflection failures can be considered localized failures in (sometimes) isolated portions of the foundation. The profile lines that were calculated are represented by a dashed black line and the areas that the deflection failures occur are represented by a dark red line segment. Of the 76 deflection profiles calculated, 5 profile failures were identified.

Deflection failures can be considered localized failures of the foundation in (sometimes) isolated portions of the foundation. Of the 76 deflection profiles calculated, 5 failures were identified.

Deflection failures are above standard acceptable limits; they exceed industry-standard thresholds and the structure should be considered actively moving/settling in areas where deflection failures are occurring.

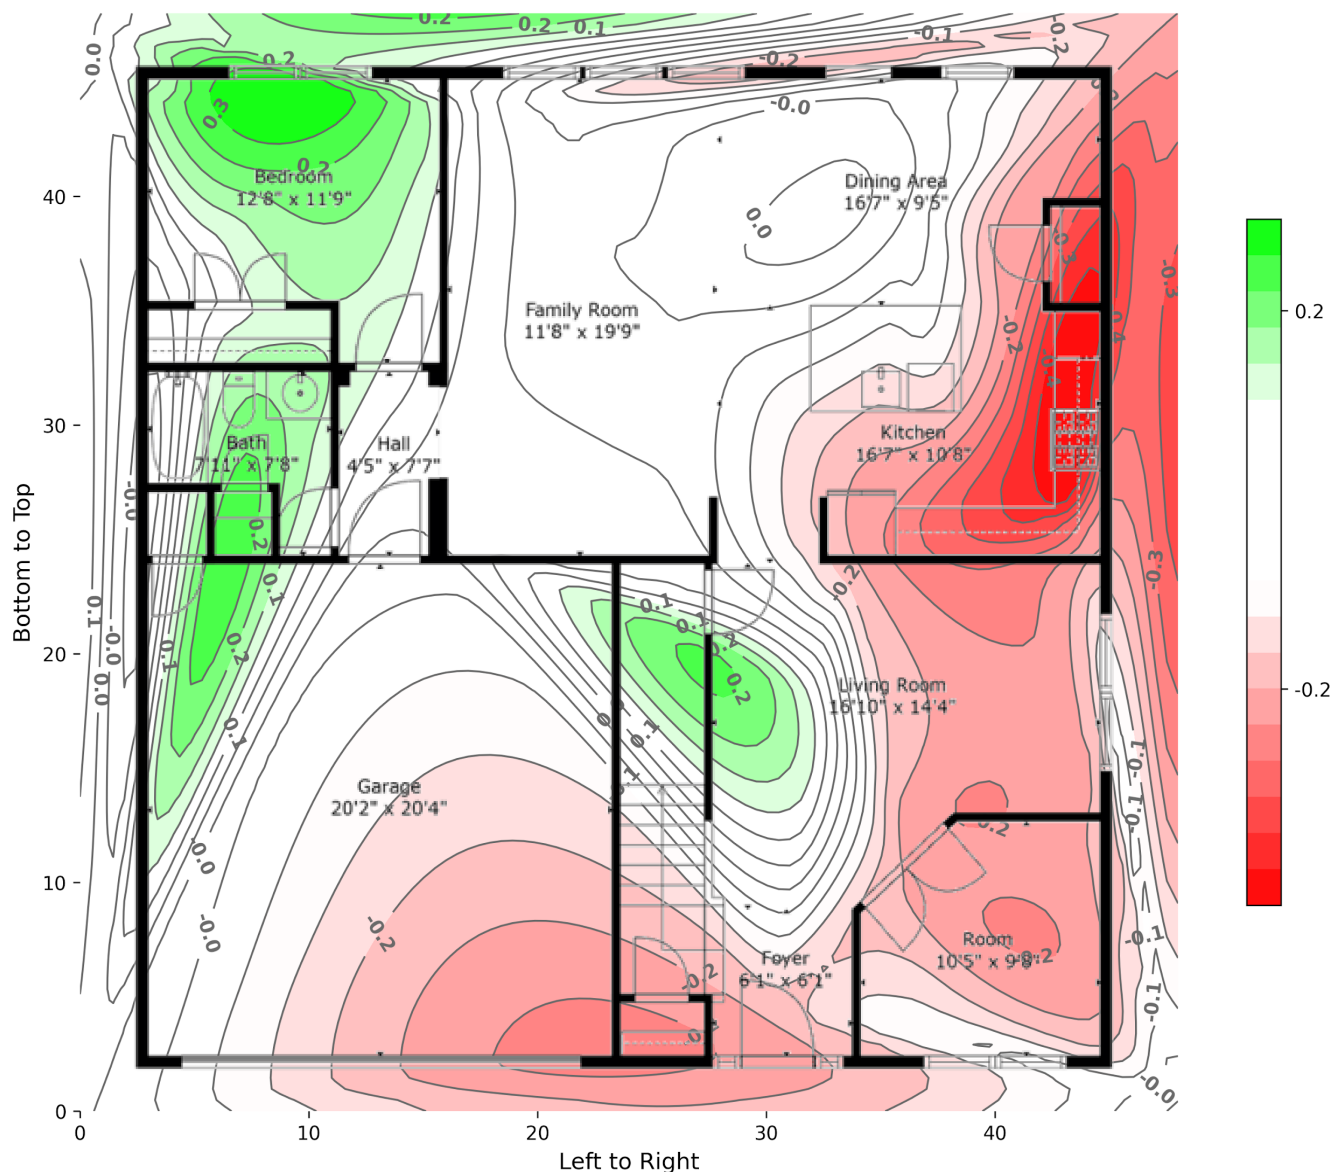
Elevation Plot Difference Graphic (Figure F)

The mesh contour graphic above in Figure F shows areas in red that are lower than the baseline elevation plot and areas of green that are higher than the baseline elevation plot (from the provided drawing completed in 1998). The darker the color (both red and green) the larger/smaller the elevation differences.

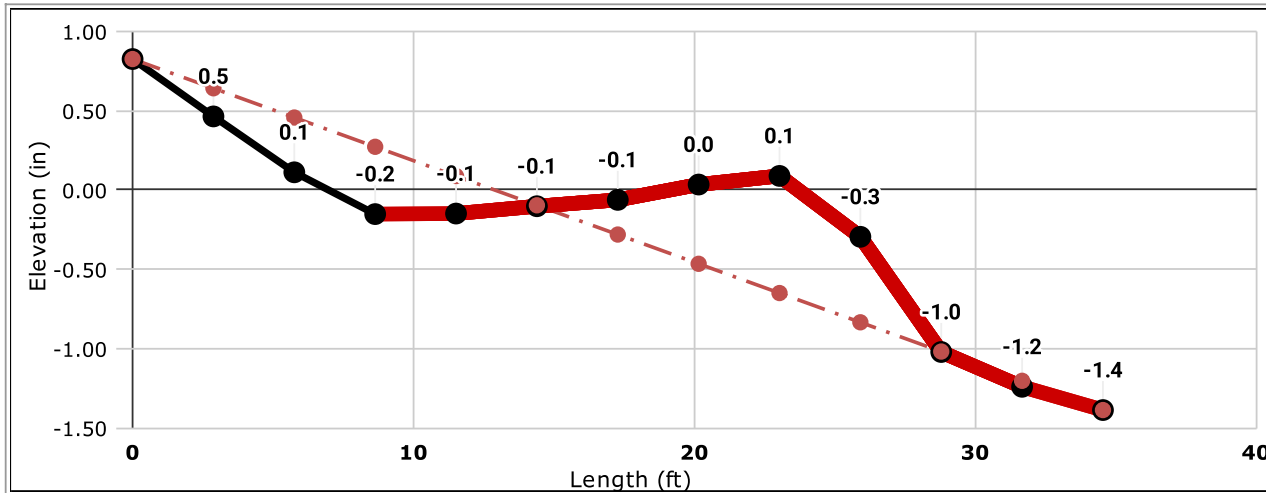
Exhibit A: Identified Deflection/Tilt Failure (L48)

Performance Output							
Deflection & Tilt	Pass/Fail	Actual		Result Description	Point 1	Point 2	Point 3
Deflection 1 (using k)	FAIL	L /	281	EXCEEDS THE kL/360 (L/340) LIMIT BY 21%	4	9	11
Deflection 2 (using k)	FAIL	L /	281	EXCEEDS THE kL/360 (L/340) LIMIT BY 21%	5	9	12
Deflection 3 (using k)	FAIL	L /	300	EXCEEDS THE kL/360 (L/340) LIMIT BY 13%	4	9	12
Deflection 4 (using k)	FAIL	L /	323	EXCEEDS THE kL/360 (L/340) LIMIT BY 5%	5	9	13
Deflection 5 (using k)	FAIL	L /	326	EXCEEDS THE kL/360 (L/340) LIMIT BY 4%	6	9	13
Tilt	PASS	0.53	%	USING 53% OF THE ALLOWABLE 1% LIMIT
